# Arboricultural Assessment

50 Walder Rd, Hammondville

Prepared for Liverpool City Council, C/- TreeServe Pty Ltd.  
785-811 Wallgrove Road, Horsley Park  
NSW 2175

REF: 20240303/01

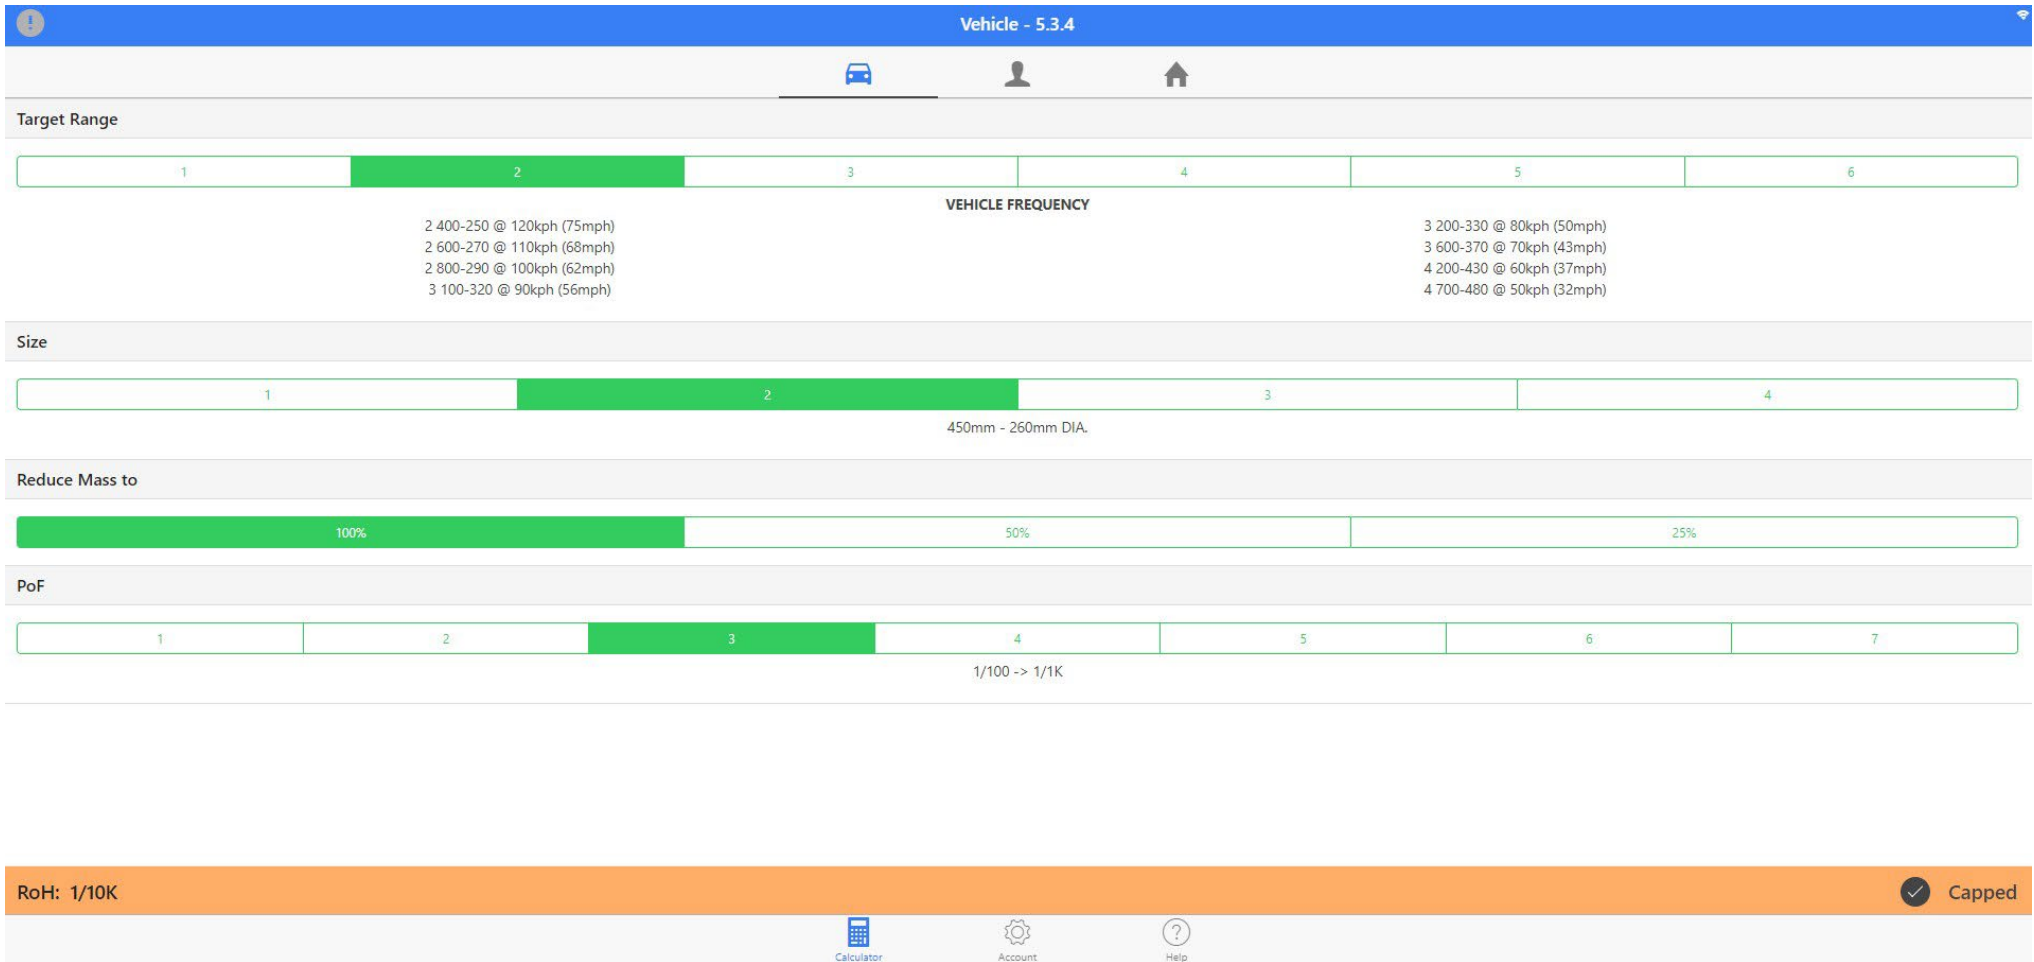
**Figure 05:** QTRA calculation for the subject tree (QTRA App. Version 2.0.6)

4.3.7 In determining an annual risk of harm (RoH), a failure of a first order lateral (discussed in 4.3.5) onto a dynamic target (vehicle) was considered the highest risk. QTRA target range 2 provides a vehicle frequency rate between 4,700 – 480 per day (24Hrs) @ 50km/h (posted speed limit is 50km/h, plus reduction to 40km/h during school peak times). Size part is range 2, 450mm - 260mm in diameter. Probability of failure (PoF) is estimated at range 3, 1/100 - >1/1,000. The QTRA output provides an annualised risk of harm of 1/10,000 which may be tolerable by agreement, although in this circumstance, an agreement with those exposed to the risk it is impracticable, if not impossible; therefore the risk is generally considered unacceptable. QTRA calculation is included below as figure 05.

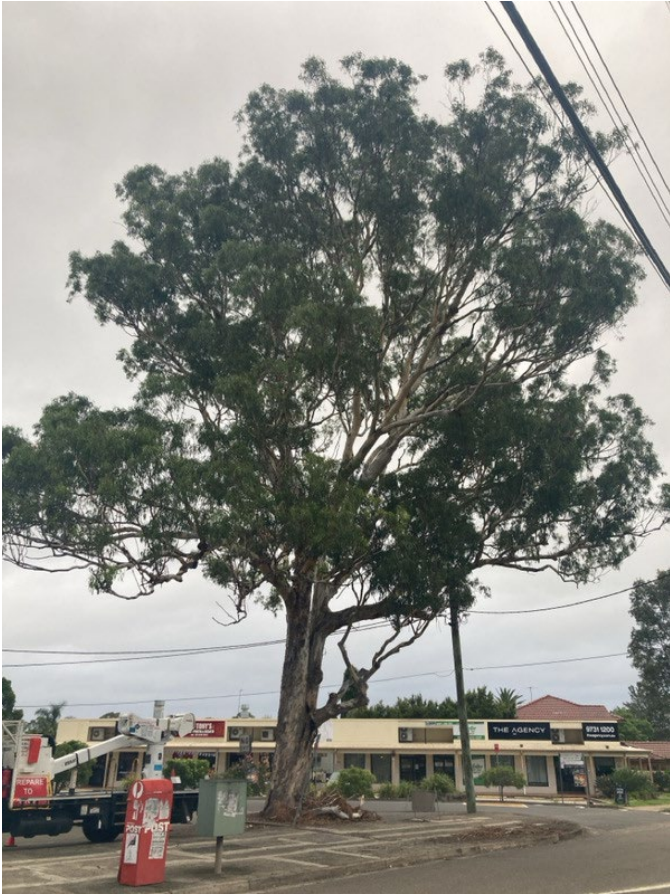
3.0.4 The subject tree is a mature specimen of *Eucalyptus bosistoana*, health is seemingly good. There is recent failure of a first order lateral on the southern side, cockatoo damage and minor decay were noted in this location. The author is unaware when the failure occurred. Most branch junctions contain cavities, and some cavities have developed on the upper side of branches. Of greatest concern was the cavity in the main junction of the northern leader, it measured approximately 420mm x 200mm; there is a crack on the tension side of the northern first order lateral and limited response growth is forming below this junction.

**Figure 01a:** The subject tree.

6.0.1 Option 01 is to remove the subject tree, thereby eliminating risk. All hollows shall be inspected immediately prior to removal; in the event fauna is found, appropriate measures are to be taken to ensure no harm occurs.

6.0.2 Option 02, if desirable to retain, the installation of a dynamic cable system may assist in short-term retention. Any such system shall be designed & installed by suitably experienced professionals, such as Total Height Safety (THS). Similar examples are present in Parramatta Park.

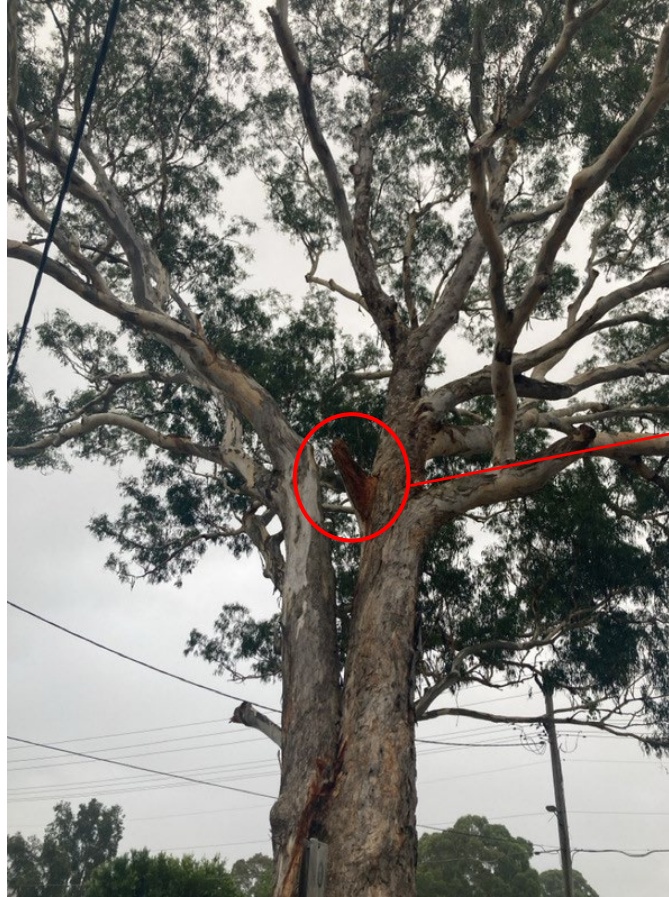
4.3.2 Bark damage & minor decay were noted at the point of failure of the first order lateral on the southern side. Similar damage is quite extensive throughout the tree. The bark damage appears consistent with that caused by Cockatoos, Galahs or Corellas, commonly referred to as ‘cockatoo damage’ or ‘cockatoo crotching’; a Sulphur-crested cockatoo (*Cacatua galerita*) was observed at the time of inspection. These species of birds often damage non-food items by chewing; this behaviour helps maintain their beaks at the appropriate length and condition. Almost all problems caused by cockatoos relates to their chewing behaviour. However, the severity relates to their social tendencies.

**Figure 01b:** Failure on southern side.

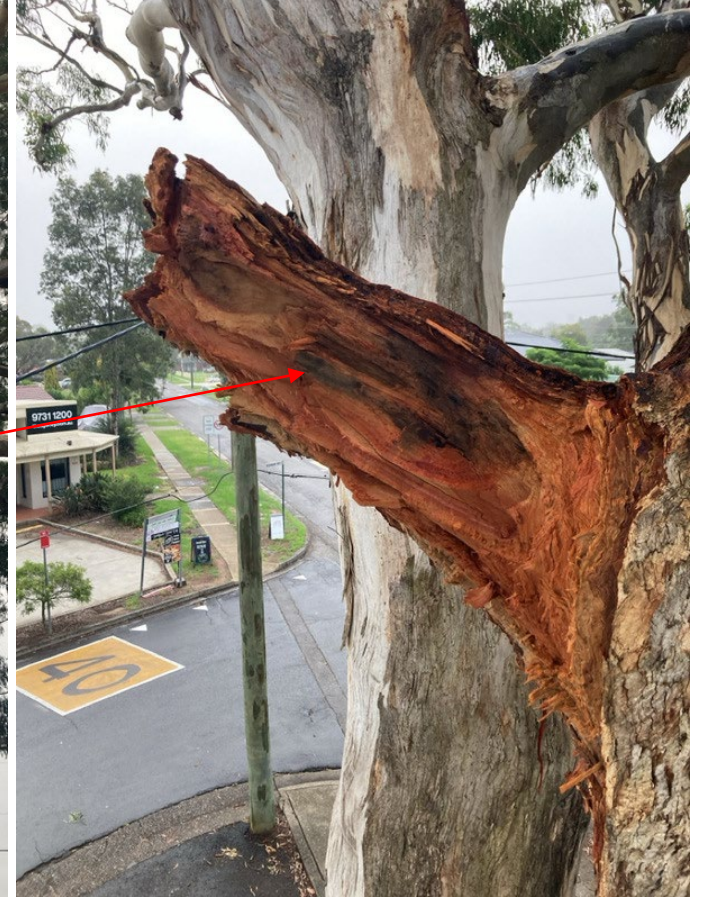
**Figure 01c:** Recent limb failure.

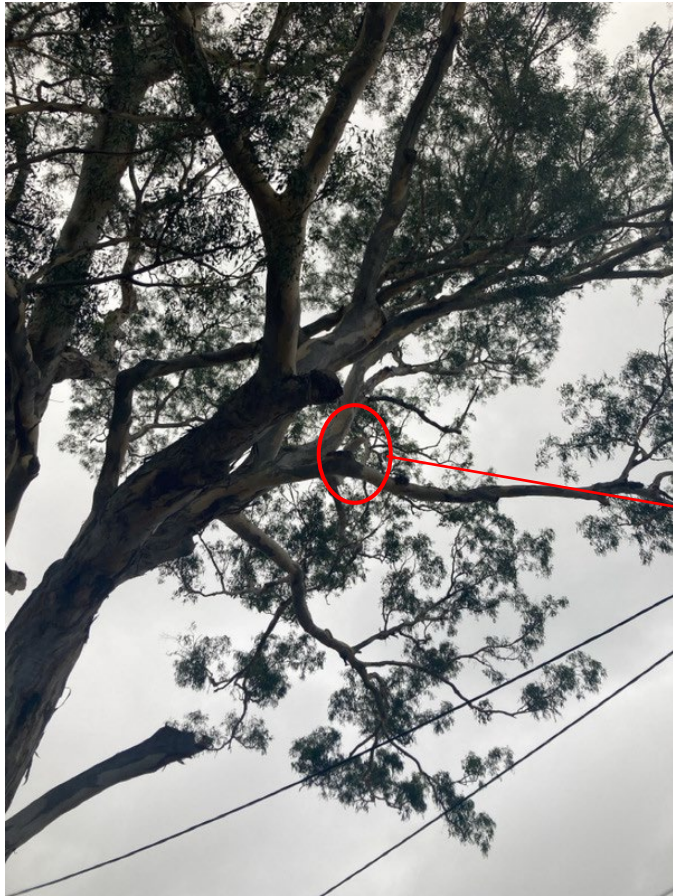
4.3.3 Due to the social tendencies of these birds, they tend to do most things in a flock, and their habitual nature means they often do the same things repeatedly. Most damage caused by cockatoos tends to be more of a nuisance than significantly detrimental to the tree; however, if the same tree is repeatedly used as a day roost, it may sustain serious damage through chewing for either feeding or beak maintenance. The removal or damage of tree bark exposes the tree to secondary pathogens. It is primarily the introduction of secondary, decay causing organisms that ultimately results in the formation of cavities; such is the case for the subject tree.

**Figure 01d:** Sulphur-crested cockatoo chewing at time of inspection.

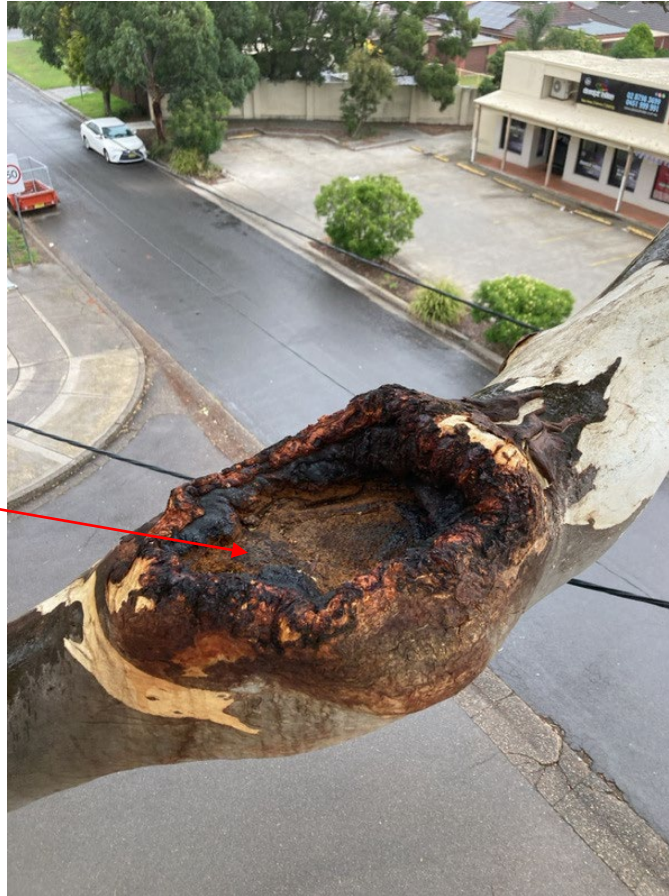
**Figure 01e:** Location of chewing at time of inspection.

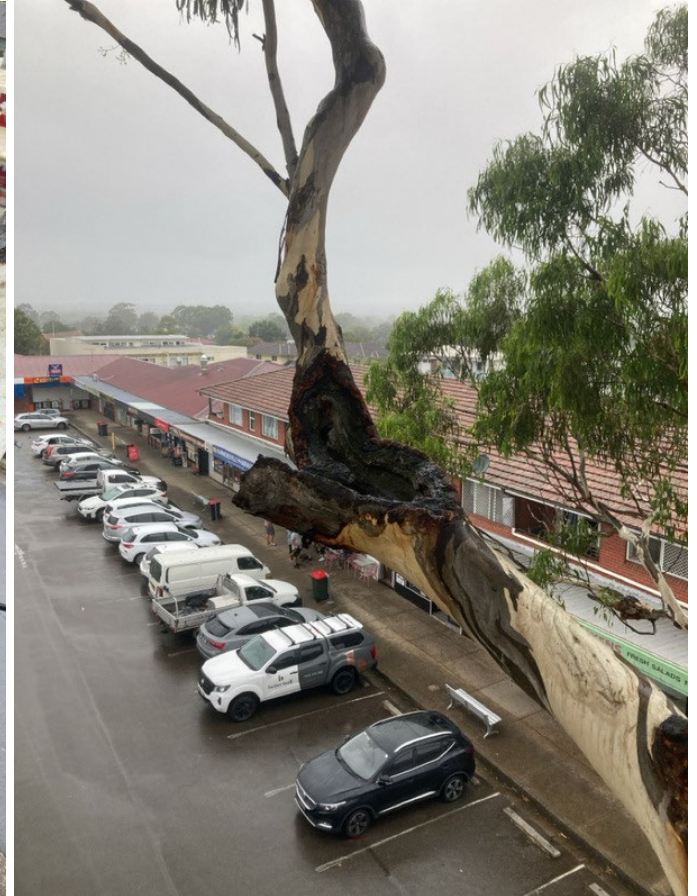
4.3.6 The majority of the other cavities were relatively shallow; however, decay is still likely at these locations and a reduction in structural integrity can be reasonably assumed. Sound response growth is developing around some wounds, but repeated damage is hindering occlusion. At the time of inspection, no nests were observed in any hollow, although birds were showing interest.

**Figure 01f:** Cavity on eastern side.

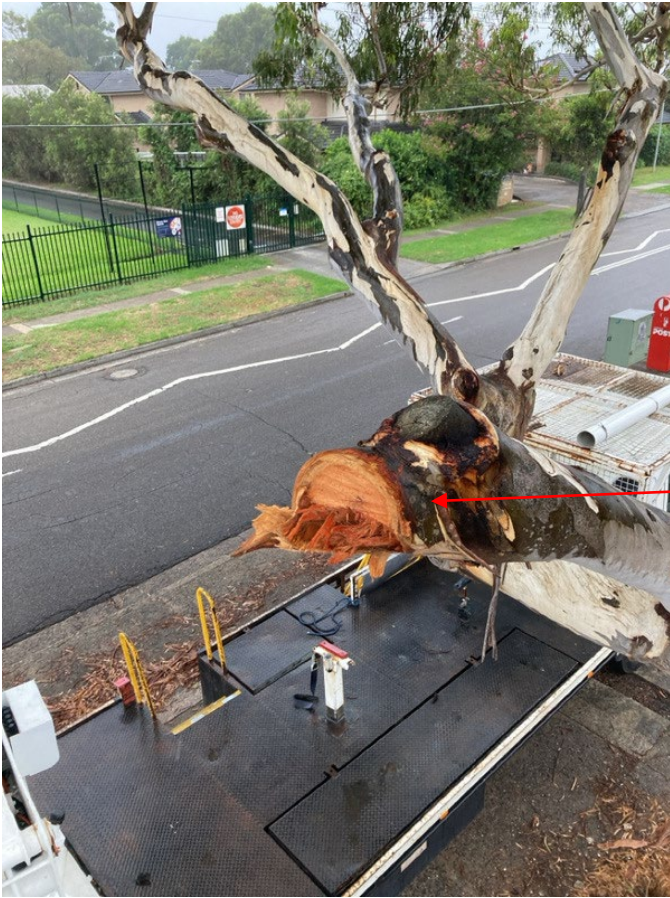
*Notes:* Co-dominant leaders formed at approx. 3m. Recent first-order lateral failure on the southern side; damaged/lopped second order lateral on western side, assuming this resulted from activities to re-connect the service wire damaged by the failure on the southern side. Cavities in almost all branch junctions and many on the top side of lateral branches, consistent with bird browse. No fauna observed in any hollow, but at the time of inspection interest was shown by Lorikeets and Sulphur-crested Cockatoos. Cavity in main junction on northern leader measured 420mm in diameter and 200mm deep; within the cavity there is a crack on the tension side of the northern first order lateral, over path, powerlines and Walder Rd, limited response growth is developing.

**Figure 01g:** Lopped second order lateral on western side.

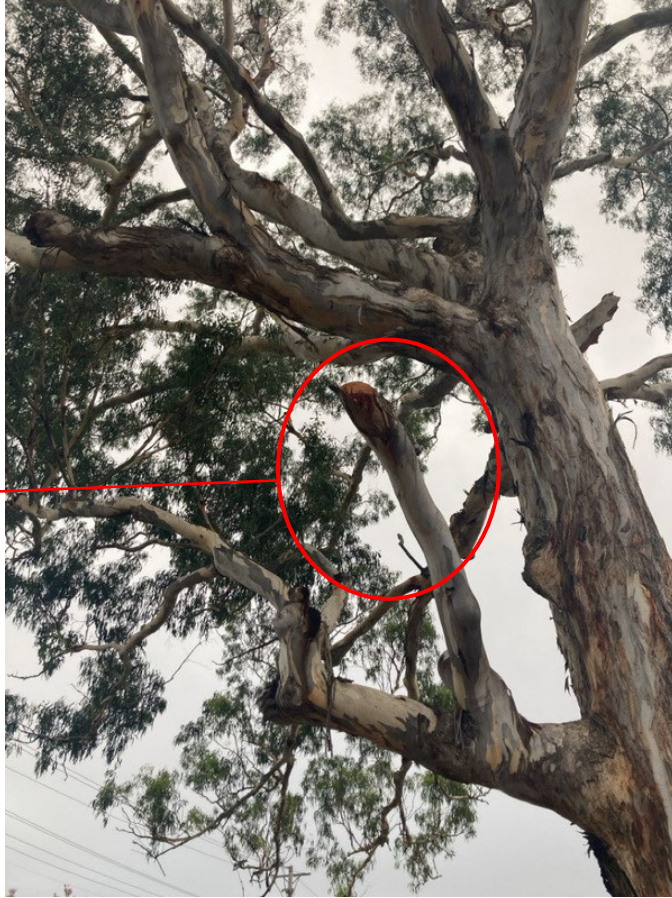
**Figure 01h:** Second order lateral.

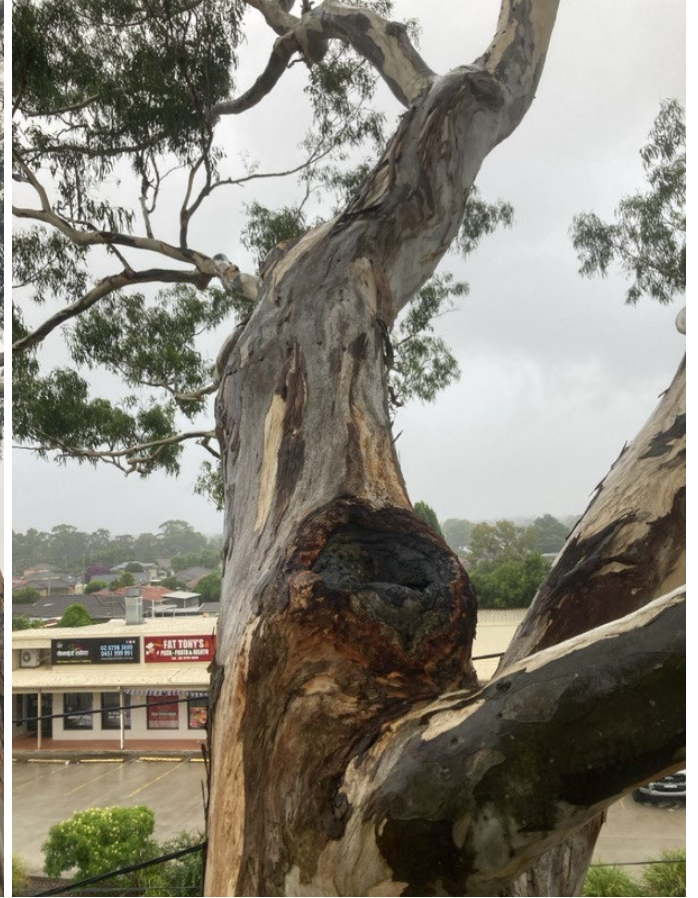
**Figure 01i:** Cavity on western side.

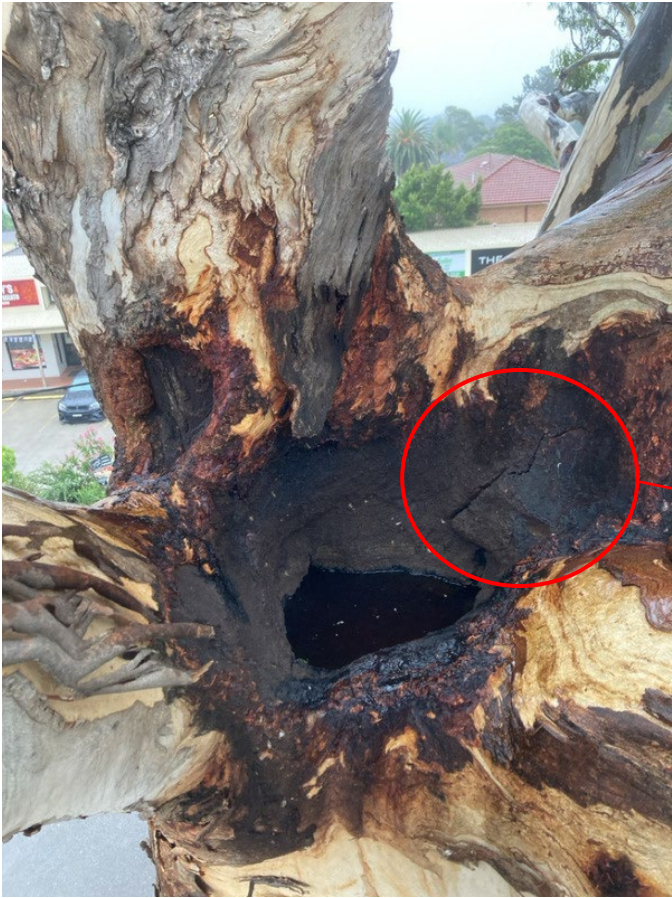
4.3.5 The largest cavity is in the junction of the first order laterals on the north-eastern leader<sup>2</sup>, it measured approximately 420mm in diameter and 200mm in depth. Within this cavity, at the base of the first order lateral on the northern side, extending over Walder Rd, a vertical crack has formed, which suggests there is torsional loading at this point. There didn’t appear to be substantial response growth forming on the compression side of this branch, which may simply mean the crack is recent and the tree has not yet produced more wood in this area, or the crack may be old and minimal adaptive growth was required to stabilise the junction; either way, the open crack is a direct entry point for secondary pathogens and further degradation of this junction is likely.

**Figure 01j:** Cavity in junction on north side.

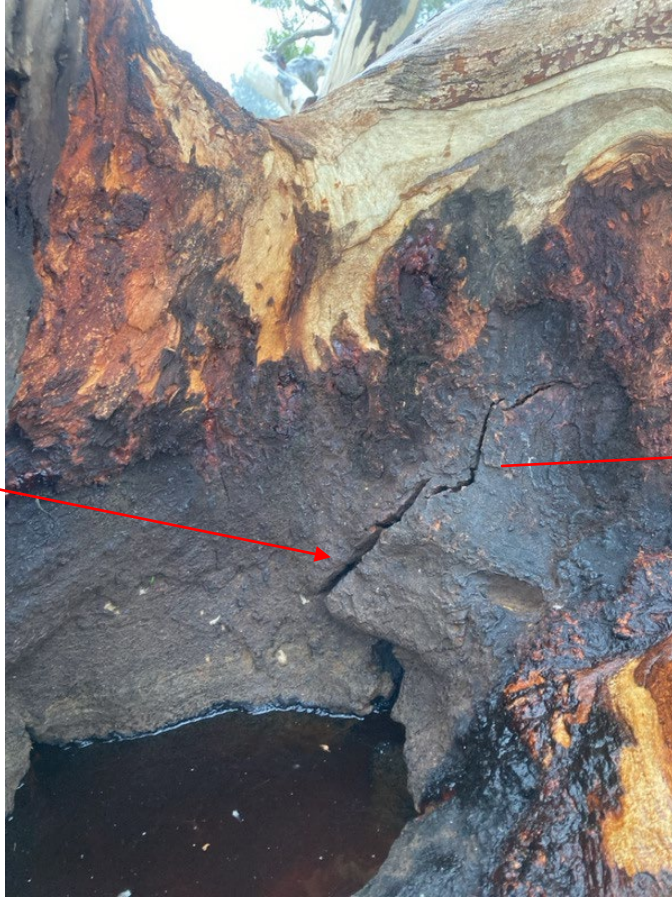
**Figure 01k:** Crack.

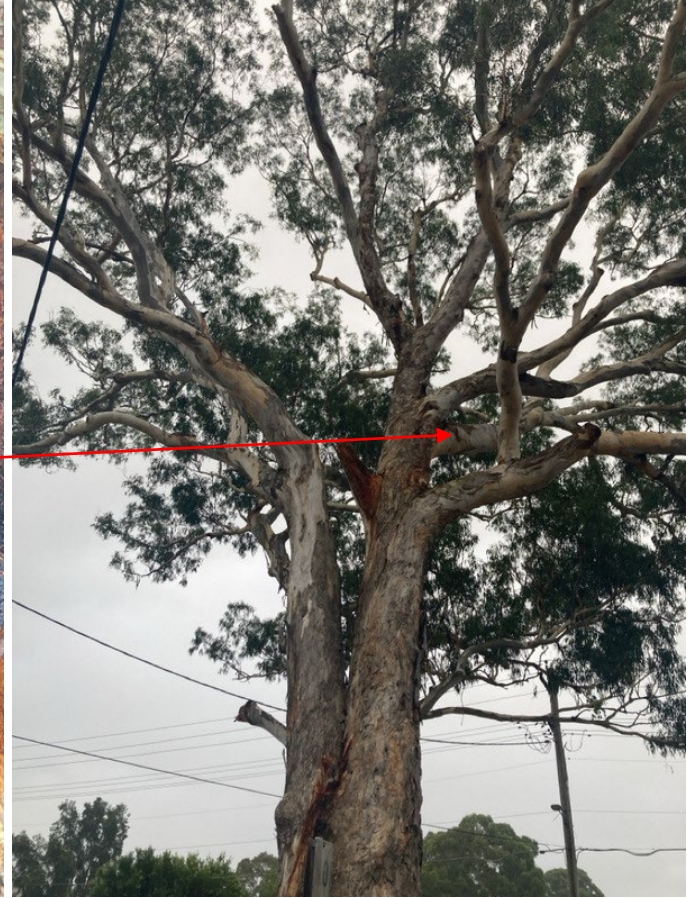
**Figure 01l:** First order lateral over road.
